Technical Memorandum No. MERL-2014-64

Coatings for Mussel Control — Results from Six Years of Field Testing

U.S. Department of the Interior Bureau of Reclamation Technical Service Center Denver, Colorado

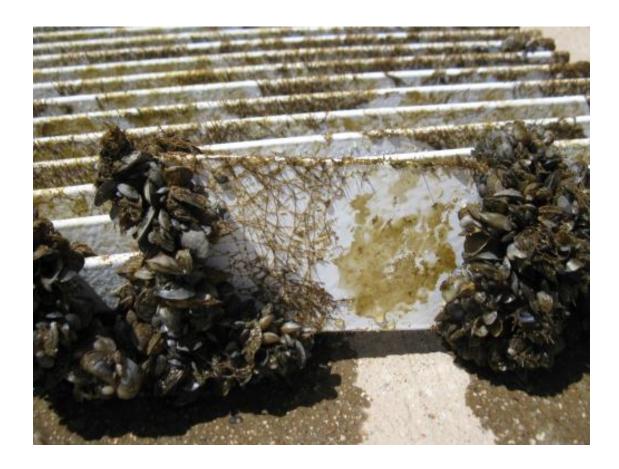
On the cover: Steel plate coated with a silicone oil-free version of Silicone FR #1 after 22 months of immersion in mussel-infested water. Mussels have attached to the back and sides of the plate, but not to the coated surface.

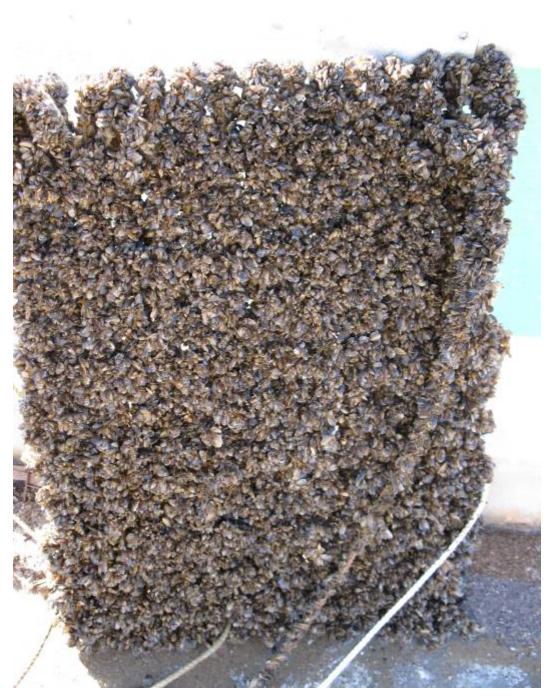
Several sets of experimental controls were used to determine fouling rates, including epoxy-coated steel, ASTM A788 steel (Figure 4) and 304 stainless steel [6, 7].

Figure 4. Uncoated steel after 7 months of exposure in dynamic conditions. Test period May 2008 to December 2008.

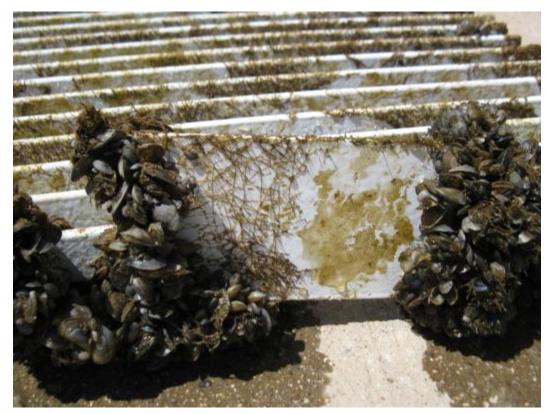
Since most silicone foul-release coatings contain a silicone oil-release additive, MERL tested a silicone oil-free version of Silicone FR #1 to determine if the mussels would attach once the oils were depleted. The results showed no mussel attachment after 22 months of exposure. (See cover photo.) The coating manufacturers use silicone oils as release agents to assist fouling release of marine organisms. Since silicone oil is designed to be consumed by leaching from the coating, foul-release performance would typically degrade over time. If oil-free coatings are effective in freshwater environments, foul-release capability may be maintained throughout the life of the coating. MERL's finding shows that the principles of foul-release coatings for marine fouling may not apply directly with freshwater fouling. Furthermore, removing the silicone oil from the formulation could provide coating manufacturers with lower-cost coatings as well as a better National Sanitation Foundation (NSF 61) approval rating for drinking water [2].

Commercially available silicone foul-release coatings contain silicone oils within the coating system that migrate to the surface over time, creating a surface that prevents adhesive wetting and bond formation. Systems are optimized to maintain oil on the surface for as long as possible, but eventually the oil becomes depleted. The performance typically degrades over time in the marine environment. MERL researchers questioned whether the silicone oil additive was essential for foul-release efficacy. The manufacturer of Silicone FR #1 agreed to provide an oil-free version for testing purposes, which was placed in testing in July 2012. The silicone foul-release coatings without silicone oil did not allow mussel attachment to the surface (shown on Figure 6 and the front cover). This new discovery may allow coating manufacturers to develop coatings with NSF 61 approval ratings for drinking water [2]. This also suggests that as long as the silicone foul-release coatings are not damaged, they will perform for the life of the coating. MERL's discovery suggests that foul-release coatings work differently in freshwater than in marine settings. This revelation could lead to the formulation of foul-release coatings designed specifically for freshwater immersion, which are better able to meet the needs of Reclamation and the industrial maintenance market.

Figure 6. Silicone oil-free version of Silicone FR #1 after 22 months of exposure.

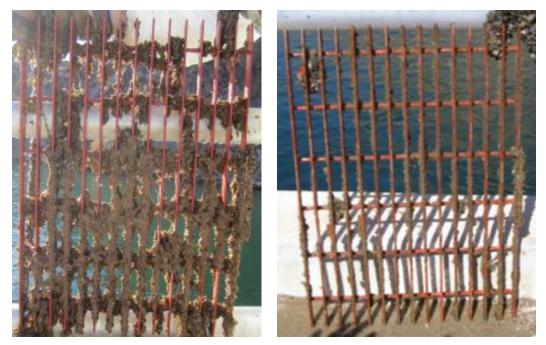
Figure 8. Grate coated with Silicone Epoxy #7, as seen in December 2013 (left) and in May 2014, after 1year of exposure (right).

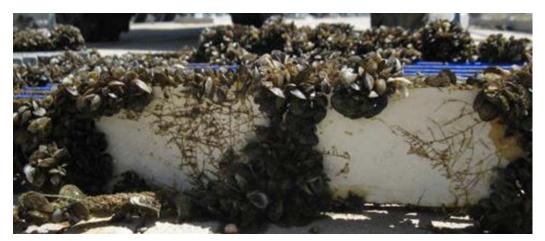
Figure 9. Panels coated with experimental formulations from 2012-MTA-8-1003 #1 and #2, exposure at 18 months.

Partner 2012-MTA-8-1003 provided four different experimental formulations. As shown in Figure 9, samples #1 and #2 have thus far prevented mussel attachment, after 18 months of exposure. Samples #3 and #4 had mixed results: some of the panels did not have any mussels while other replicates had mussels covering the entire surface. Both sets had very low release forces to remove clusters: sample #3 required 0.30 lbs, and sample #4 required 0.80 lbs. Samples #3 and #4 were removed from the study in May 2014.

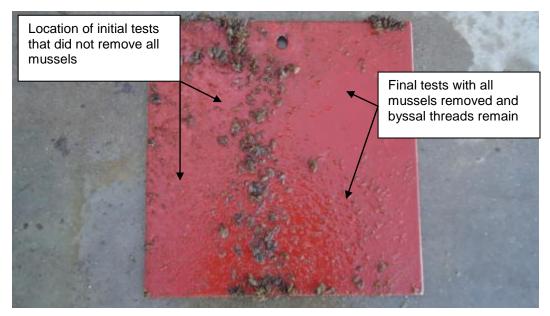
In 2011 and 2012, the Hydraulic Investigations and Laboratory performed a cleanability study including some of the durable foul-release coatings listed in Table 2. They discovered that the byssal threads remained on the surface of every hard coating or metal, which included stainless steel, coal tar enamel, coal tar epoxy, polyamide epoxy, and the durable foul-release coatings [3]. Plates with significant mussel attachment were left with byssal threads and sometimes entrails, which could not be removed with the waterjet (as seen in Figure 10). Even using a spot jet close to the surface was ineffective at completely removing the byssal threads. While it is undesirable to have threads remaining on the coating surface, it may not be necessary to have them completely removed, as they do not significantly increase flow friction or head differential. The waterjetting study suggested that the durable foul-release coatings tested offer no advantage over a conventional epoxy or coal tar enamel in situations where waterjet cleaning is expected to be utilized.

Figure 10. Silicone Epoxy FR #1 sample after release pressure testing.

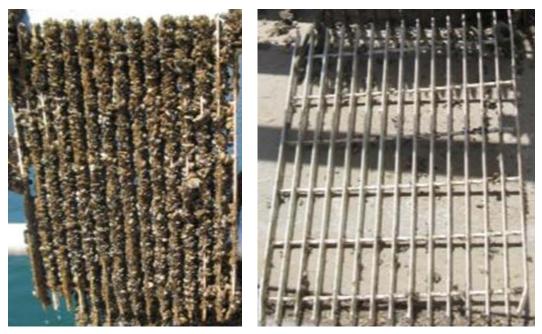
Figure 12. Grate treated with RTV Silicone ice phobic coating, before cleaning (left) and after cleaning (right), May 2014.
