**Minute 319 Colorado River Delta Environmental Flows Monitoring**

**Initial Progress Report**

**December 4, 2014**

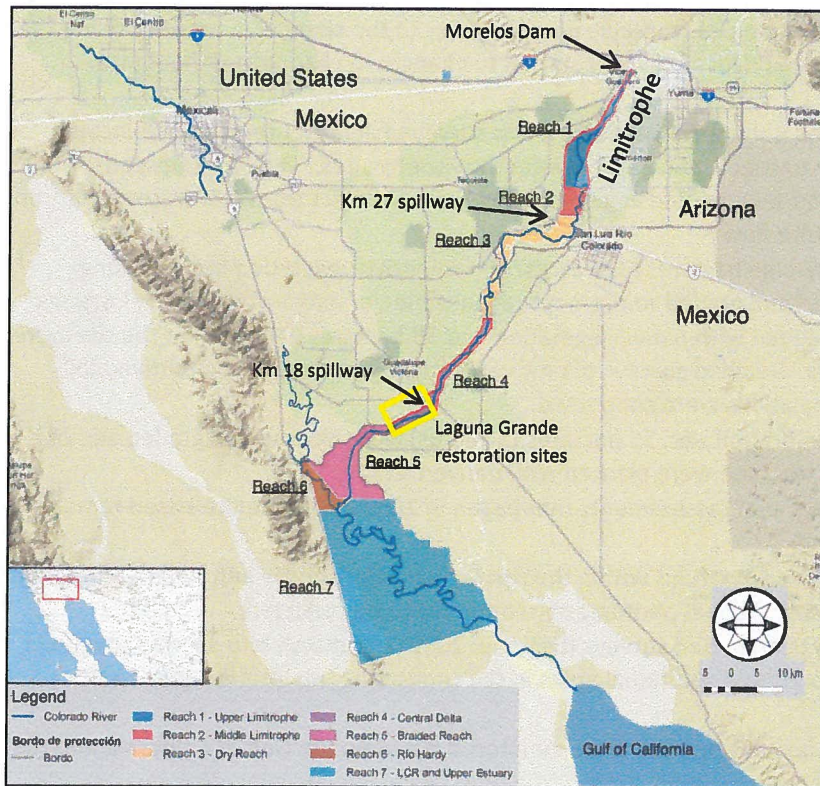
**Figure 1.** Colorado River Delta study reaches for Minute 319 monitoring activities.

The pulse flow delivered a total of 132<sup>1</sup> million cubic meters (mcm) (107,000 acre-feet [af]) to the riparian corridor of the Colorado River Delta, starting March 23 and ending on May 18, 2014. Water was delivered from Morelos Dam, and from the Km 27 spillway of Canal Reforma (river km 37; river mile 23) and the Km 18 spillway of Canal Barrote (river km 79; river mile 49) (Fig. 1 and Fig. 2).

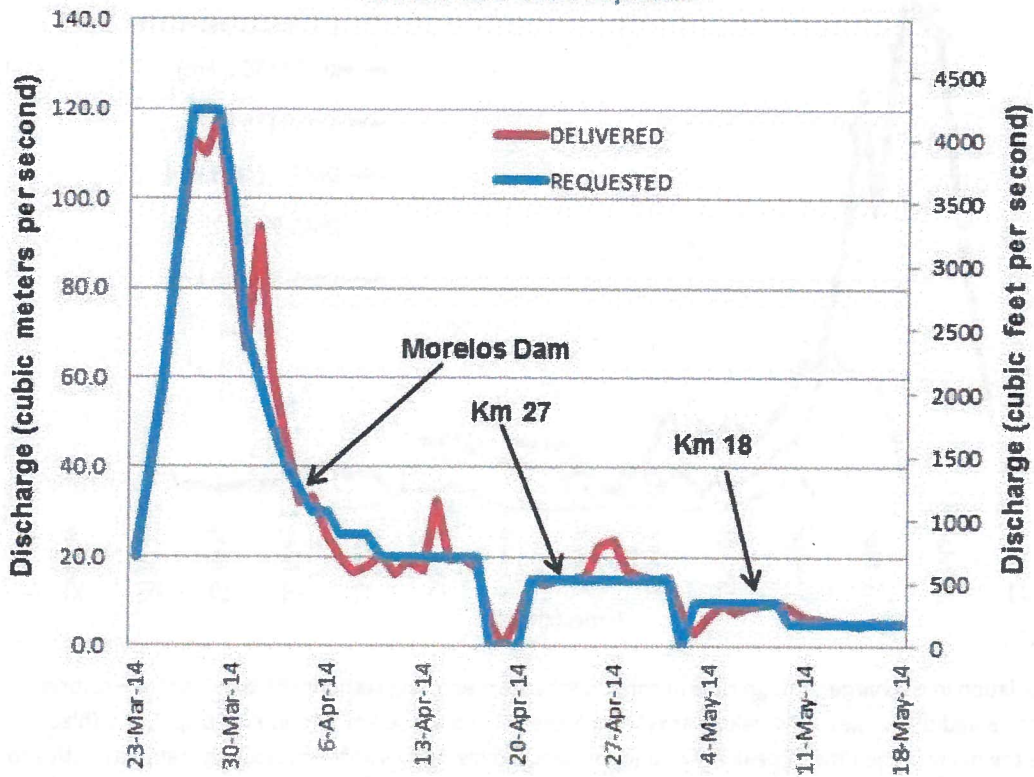
**Figure 2.** Delivered and requested pulse flow water deliveries to the study area. Scheduled Morelos Dam deliveries began on March 23 and ended on April 17; deliveries from the Km 27 spillway of Canal Reforma (at river km 37; river mile 23) began on April 13 and ended on May 1; deliveries from the Km 18 spillway of Canal Barrote (at river km 79; river mile 49) began on May 3 and ended on May 18, 2014. Source: Mexican Section of IBWC.

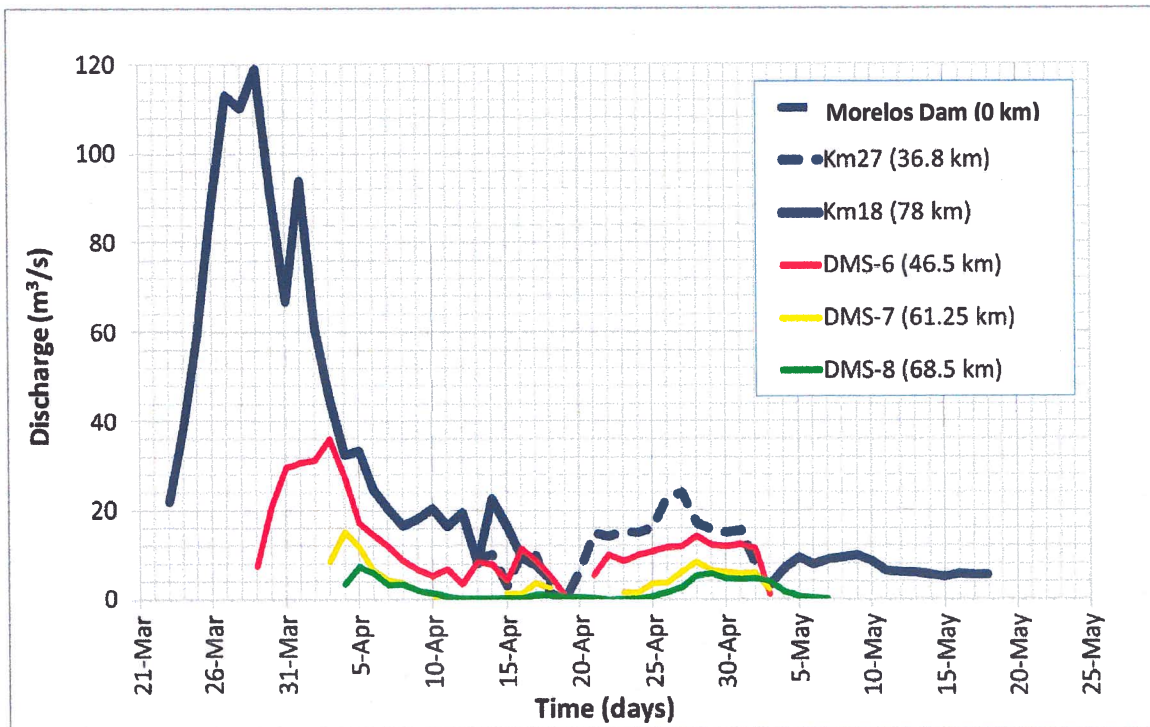
**Figure 3.** Variation in discharge through time at three discharge measuring stations (DMS 6, 7 and 8 – colored lines) in Reach 3 and discharges at Morelos Dam (Presa Morelos) and at the Km 27 and Km 18 spillways (black lines). Note the delay in the time of peak flows, and the reduced discharges at the measuring stations relative to the Morelos Dam and Km 27 spillway. Km 18 releases occurred downstream of DMS 8 and had no effect on the discharges measured upstream. Scale conversion: 100 m<sup>3</sup>/s (cubic meters per second) is approximately 3,500 ft<sup>3</sup>/sec (cfs). Distance information (in parenthesis) indicates distance of measuring stations from Morelos Dam, in kilometers.

Streamflow decreased rapidly with increasing distance downstream (Fig. 3). The pulse flow's surface water front advanced at highly variable rates (Fig. 4; from about 1 to 20 km per day or 0.5 to 13 miles per day), advancing faster when the channel surface was wet than when it was dry. The pulse flow reached the Laguna Grande restoration sites in Reach 4 on April 5-6. Pulse flow releases from the Km 18 spillway, which began on May 3, enabled the water front to resume its downstream flow; pulse flow water connected with tidal water from the Gulf of California in the afternoon of May 15, 2014 (Fig. 5).

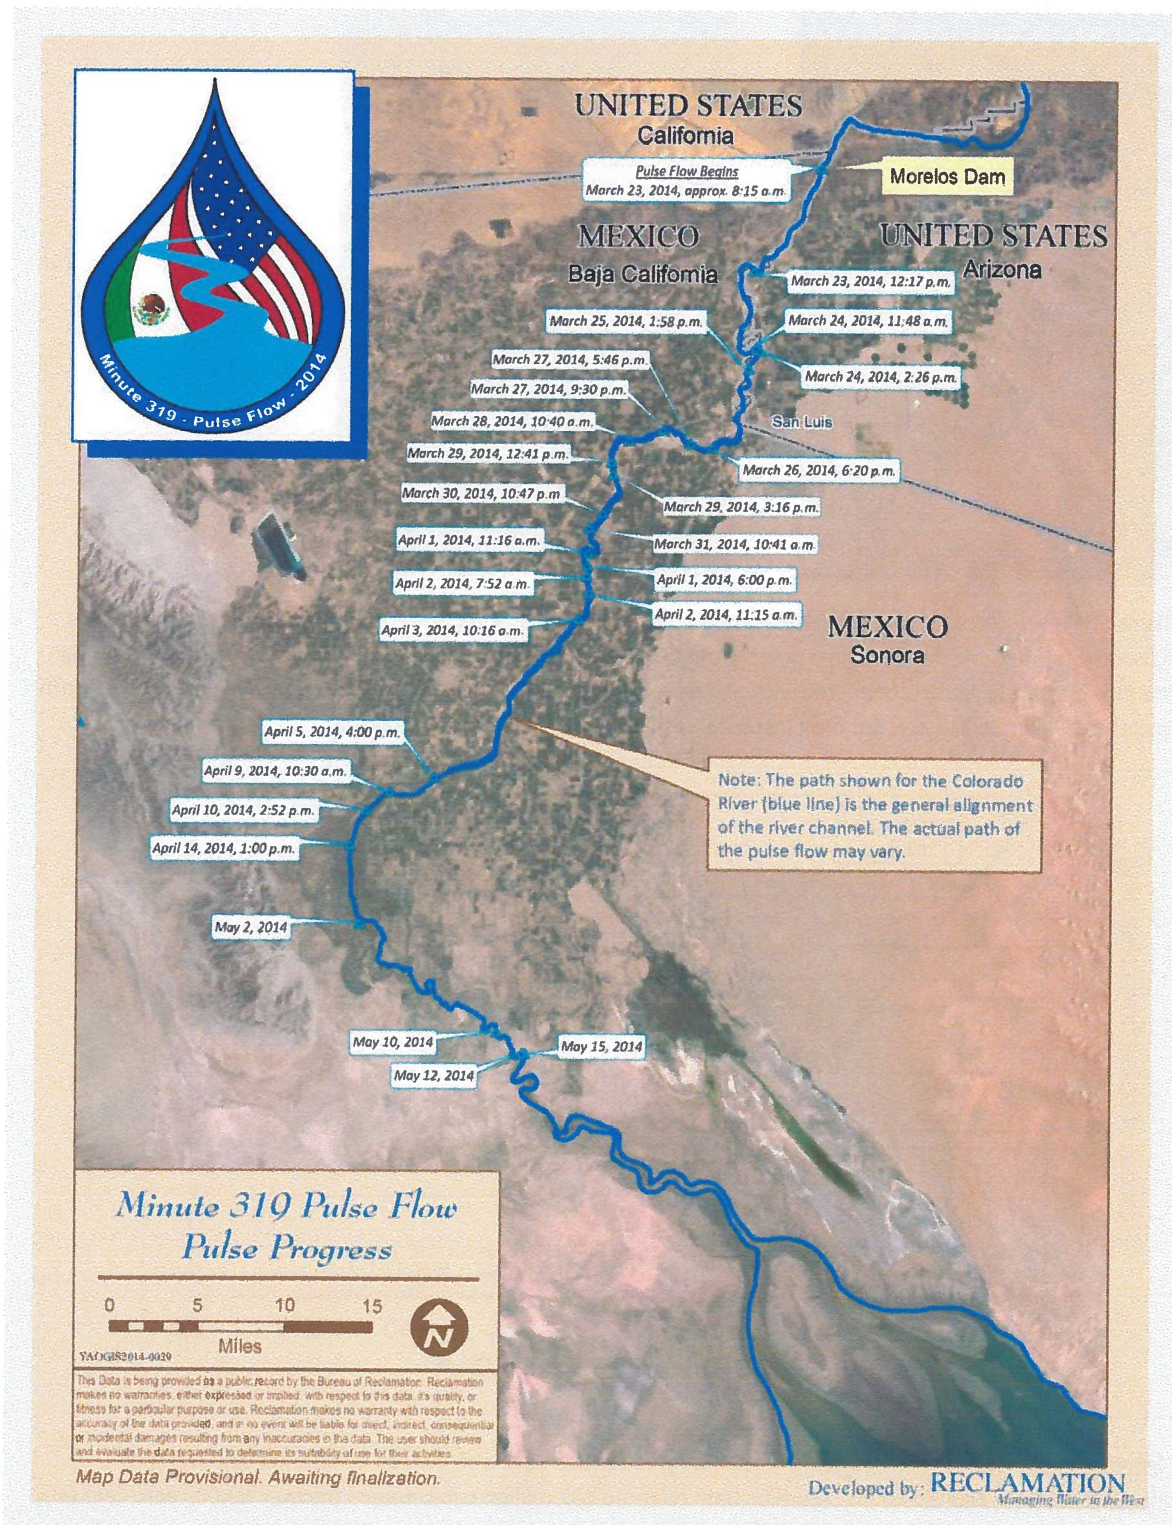
**Figure 4.** Progress of surface pulse flow water. Source: U.S. Department of the Interior, Bureau of Reclamation.

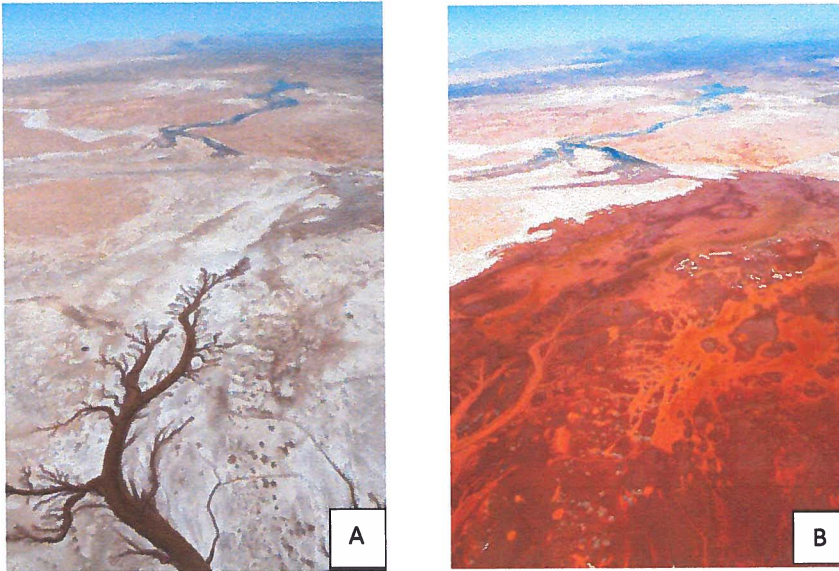
**Figure 5.** View looking north, from tidal waters of the Gulf of California (lower) to approaching Colorado River pulse flow (upper). **A.** Tidal channel (lower) and Colorado River (upper) May 13, 2014. **B.** Flooded area at high tide (lower, muddy water) connected with pulse flow of Colorado River (upper, blue water). May 15, 2014. Both images by Francisco Zamora, Sonoran Institute, with aerial support from LightHawk.

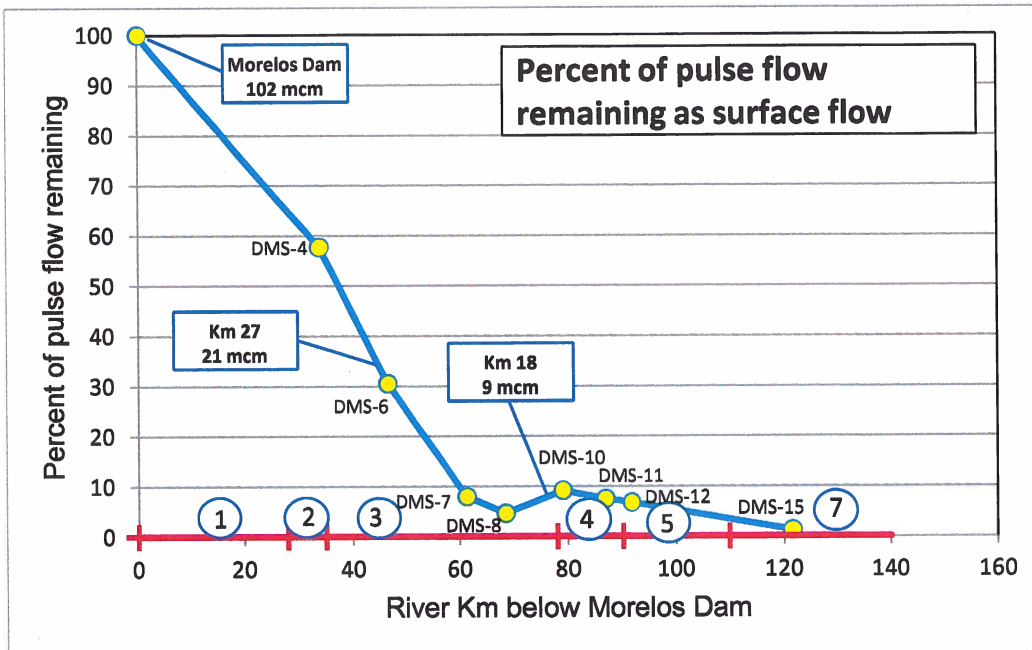
**Figure 6.** Percentage of total pulse flow remaining as surface flow with increasing distance (as river km) downstream from Morelos Dam. Morelos Dam released 102 million cubic meters (mcm) = 83,000 acre-feet (af); Km 27 spillway released 21 mcm = 17,000 af; Km 18 spillway released 9 mcm = 7,000 af. DMS numbers refer to discharge measuring stations. Circled numbers between red tick marks indicate river reaches. Distance scale: 60 river km = 37 miles; 100 km = 62 miles.

Most of the pulse flow's water infiltrated to groundwater, transpired from plants, evaporated from soil and water surfaces, or was retained in soil and topographic depressions. A significant portion of the pulse flow water infiltrated into the aquifer beneath Reaches 1, 2 and 3. More than 90 percent of the water released from Morelos Dam and Km 27 spillway did not flow farther than river km 60 (river mile 37), 26 km (16 mi) downstream of the Southerly International Boundary (Fig. 6).

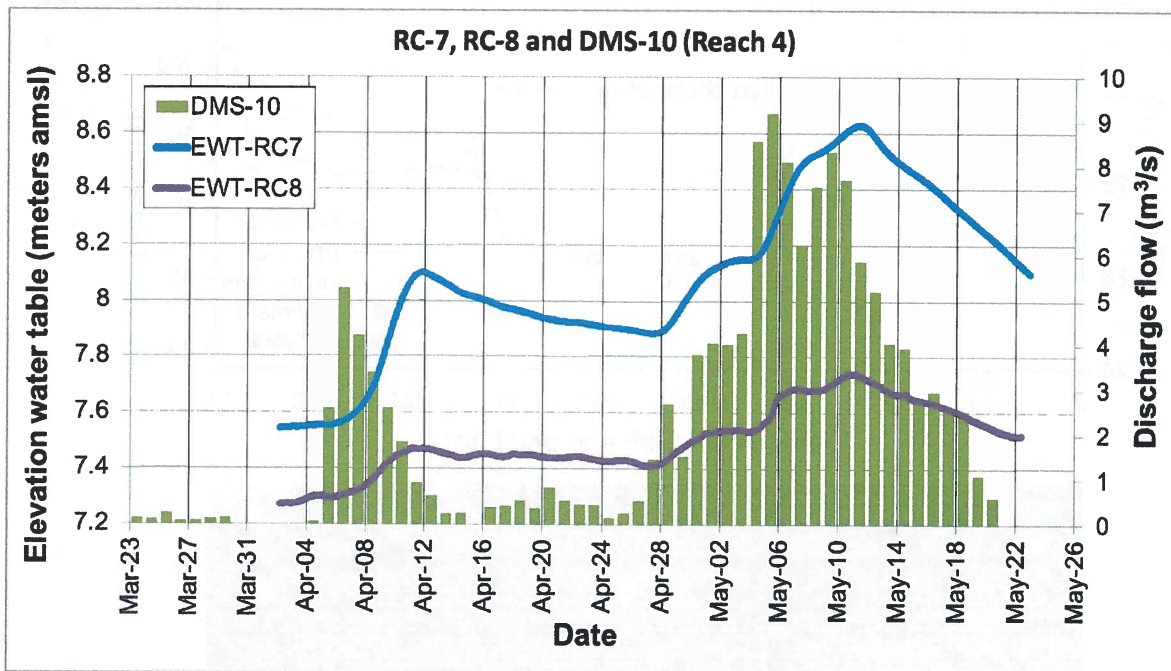
**Figure 7.** Example of groundwater response to pulse flow in Reach 4. Green bars show surface discharge at DMS 10 through time. Solid lines show elevation of water table (EWT) above mean sea level at two locations downstream (RC-7, RC-8) of DMS 10. English equivalents: 8.8 m = 29 ft; 10 cms = 353 cfs.

The water table in all reaches rose in response to the pulse flow. Aquifer response to the pulse flow varied along the river, across transects, and with time. Generally, groundwater behavior mimicked surface-water fluctuations. Groundwater effects dampened with increasing distance from the active channel. The initial slow groundwater-level rise in dry sediment was followed by more rapid changes in groundwater levels as the sediment saturated. The water table then declined at varying rates after its peak (Fig 7). Quantitative models are being developed to describe and predict infiltration behavior of surface water under various conditions.

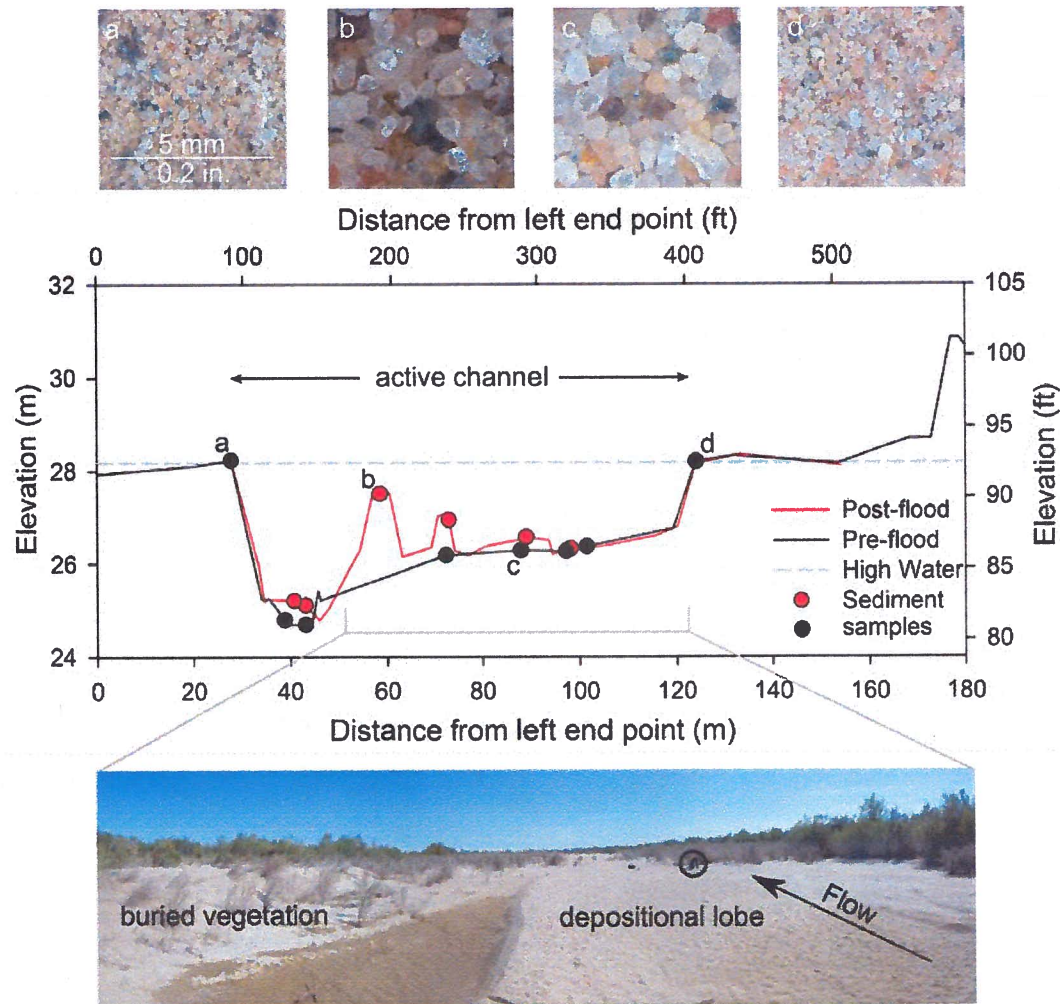
**Figure 8.** Example of channel change at USGS cross section 12 in the Limitrophe reach (32° 34' 20" N; 114° 48' 36" W [NAD83]). (Top) Microscope camera ("sandcam") images of sediment at different locations across the channel as indicated in the middle panel. (Middle) Pre- and post-flood surveys showing net aggradation at this cross-section. Black and red dots show the location of pre- and post-flow sediment samples, respectively. Vertical axes show elevation above mean sea-level (NAVD88). (Bottom) Image looking downstream at the cross-section; a person is circled for scale at the location of the cross-section.

Channel and floodplain sediments are predominantly sand. In places, the pulse flow scoured sediment to depths of approximately one meter (3.3 ft), and deposited about two meters (6.6 ft) of sediment farther downstream. Scour and deposition modified the channel bed topography (Fig. 8), but bank erosion of the existing channel was minor. Models are being developed of sediment movement under different flow regimes in order to understand and predict geomorphic changes resulting from river flows.

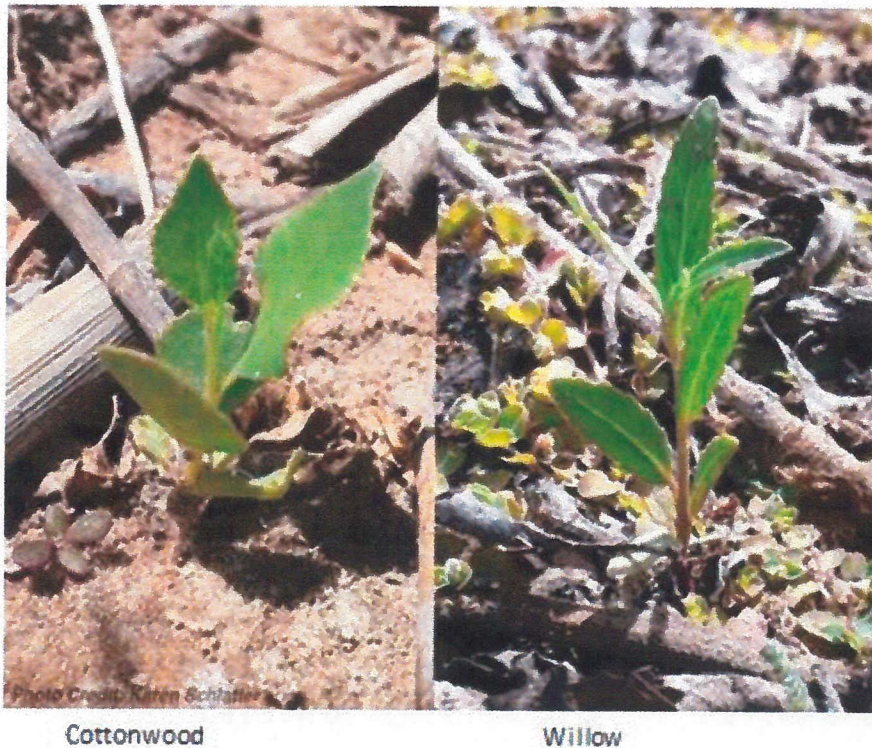
**Figure 9.** Cottonwood (left) and willow (right) seedlings in the Laguna Grande restoration site on May 17, 2014, approximately 1.5 months following the arrival of the pulse flow to the site. Seedlings are approximately 4-5cm (1.8 inches) in height.

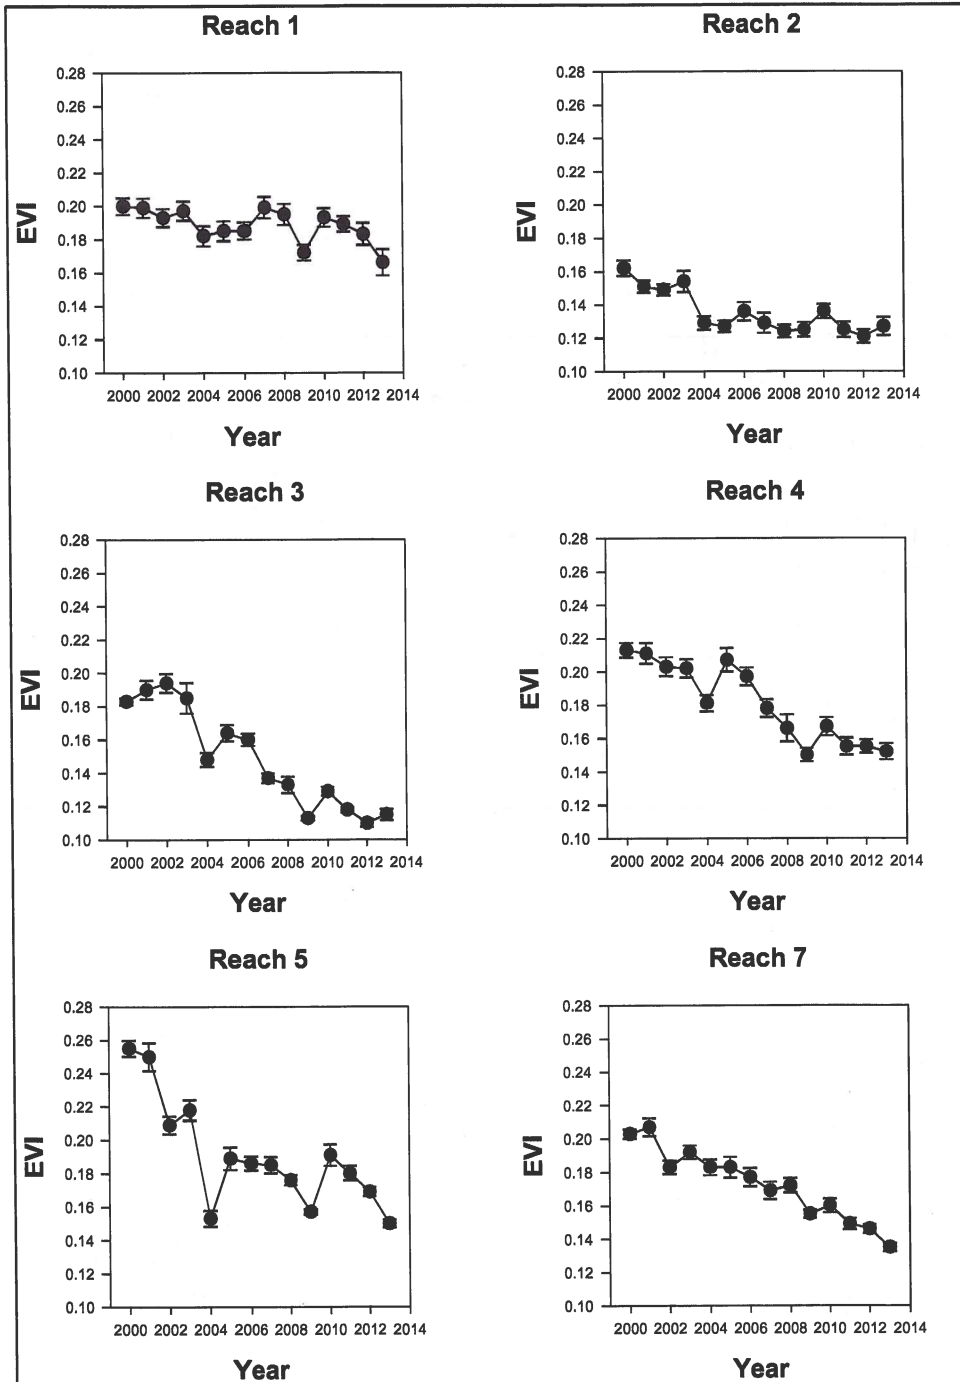
**Figure 10.** Decrease in the Enhanced Vegetation Index (EVI) from MODIS imagery in Colorado River Delta river reaches, 2000- April 9, 2014. Annual means are based on 23 16-day composite collections at 5 sites per reach.

Error bars are standard errors of means. Across reaches, EVI decreased by 31%, which corresponds to a 59% decrease in green foliage density after subtracting out the value for bare soil (about 0.1).

Growth and survival of native and non-native seedlings will mostly depend on soil moisture derived from groundwater. Green vegetation, as measured by the MODIS satellite sensor, decreased steadily in all river reaches from 2000 through April 9, 2014 (Fig. 10), indicating increased plant water stress. Preliminary remote-sensing data (June 2014) and aerial observations suggest that greenness has increased since the pulse flow. Landsat 8 imagery over all river reaches showed a 36% increase in NDVI (Normalized Difference Vegetation Index - a measure of greenness) in June, 2014 compared to June, 2013. NDVI increased in all reaches except Reach 4, where vegetation had been cleared prior to the flow

event to promote flooding and germination, and Reach 6, which drains the Rio Hardy and is above the confluence with the Colorado River. A marked greening occurred in Reach 7 at the end of the pilot canal where water from the pulse spilled onto the floodplain.

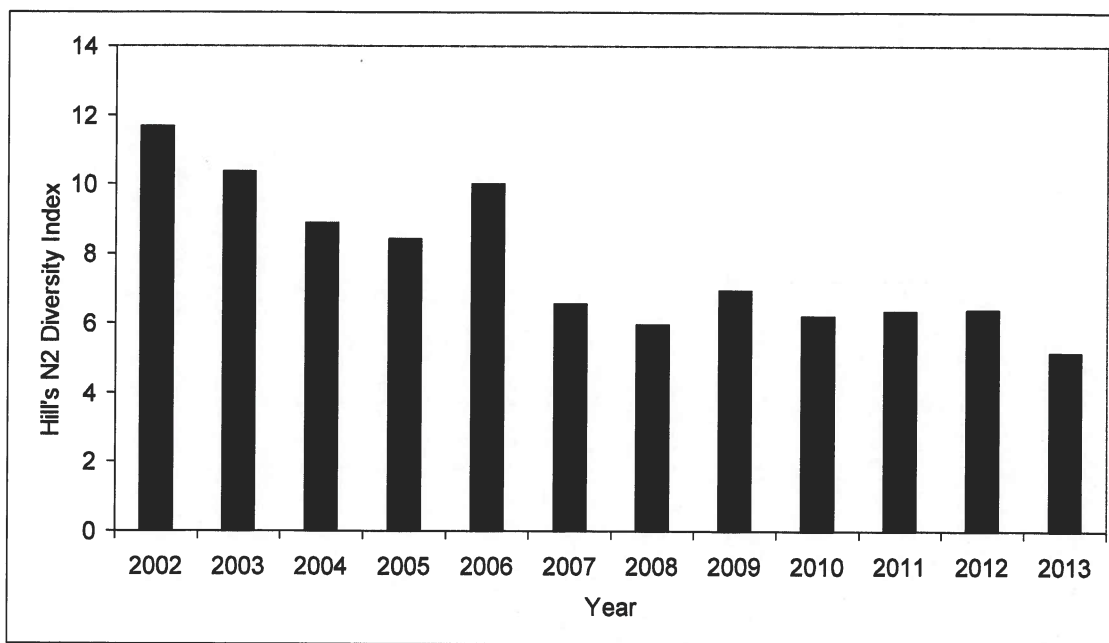
**Figure 11.** Average avian diversity (Hill's N2 Diversity Index) per point from 2002 to 2013 at 136 survey sites along the floodplain of the Colorado River in Mexico, between the Southerly International Boundary and the confluence of the Colorado with the Hardy River.

Average abundance of birds in the riparian corridor has increased from 2002 to 2013, but species diversity has decreased (Fig. 11) and composition has changed. The abundance of riparian-dependent land birds and breeding water birds has declined, while the abundance of birds related to agricultural and urban development, exotic birds, and raptors has increased. Spring 2014 surveys were conducted during the pulse flow; winter 2014 surveys were conducted in January 2014 before the pulse; summer 2014 surveys were conducted after the pulse. No changes were observed in the spring 2014 surveys in the riparian zone relative to the previous spring. Preliminary analyses suggest an increased presence of migratory birds along open water areas but the abundance of migratory birds is controlled by many factors in addition to changes in this local habitat. Bird abundance and species richness were higher in the active restoration sites than throughout the rest of the floodplain. Bird populations are expected to change if existing and new vegetation responds to the pulse flow. Such changes should be evident from longer-term monitoring activities.
