2015 SOUTHERN PAIUTE CONSORTIUM
Colorado River Corridor Resource Evaluation Program
Annual Report of Activities

Report of work carried out under Southern Paiute Consortium Cooperative Agreement with the
Bureau of Reclamation, #R11AP40007-R10PC40021

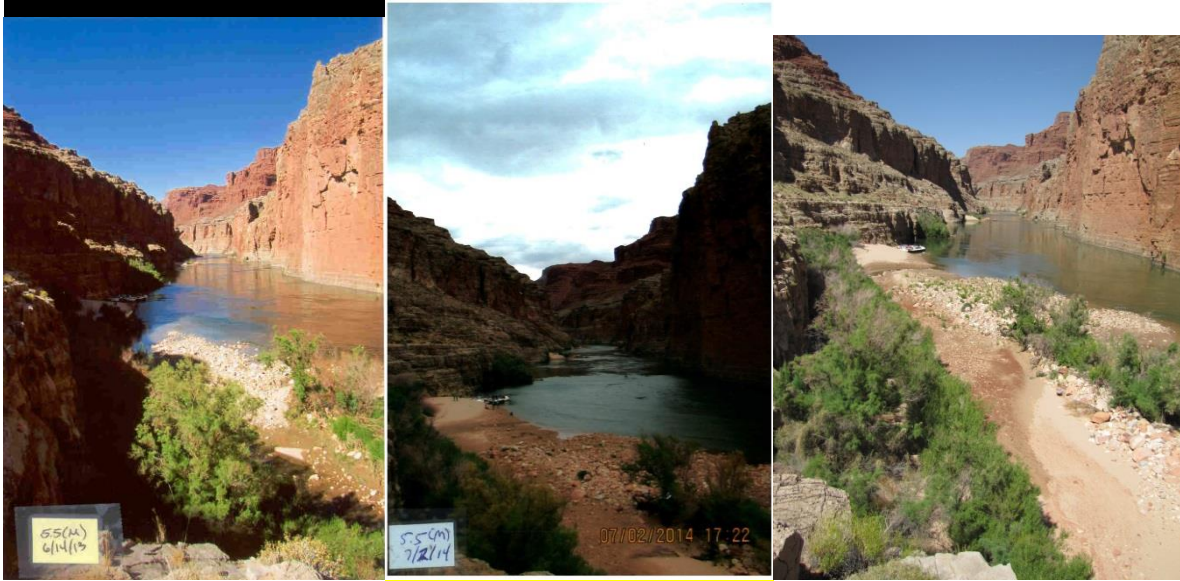
Beach monitoring was carried out in 2015. There are several notable changes. The November High Flood Experiment (HFE) has led to even greater deposition than the 2014 HFE. Midway up the canyon the wash was silted in with sand deposits likely from the HFEs. Additional effects of flooding at the site include boulder movement, greater debris and small rocks, and different height and placement of the sandbar. The deposition has covered many of the rock landmarks used during the photo matching.

Figure 1.1. South Canyon: sediment change and continued build-up of the beach, looking upriver 2013 (left), 2014 (middle), 2015 (right)

Visitation to this site remains high, so monitoring of this beach, the rock writing, hidden collection of artifacts at the rock structure, and trailing near the rock boulders will continue annually. The SPC has noted at this site that artifacts are being moved around, into collection piles, hidden, and likely sometimes removed. The SPC is concerned with this ongoing issue, and would like the NPS to address this through further monitoring and education. Furthermore, the SPC is concerned about the increase in trailing at this site, particularly from the middle bench to the rock structure. The SPC recommends that NPS address the increased trailing. Finally, continued monitoring of the effects of regular HFEs is recommended in order to track the effects of regular high flows and the associated management of the Glen Canyon Dam on the site.

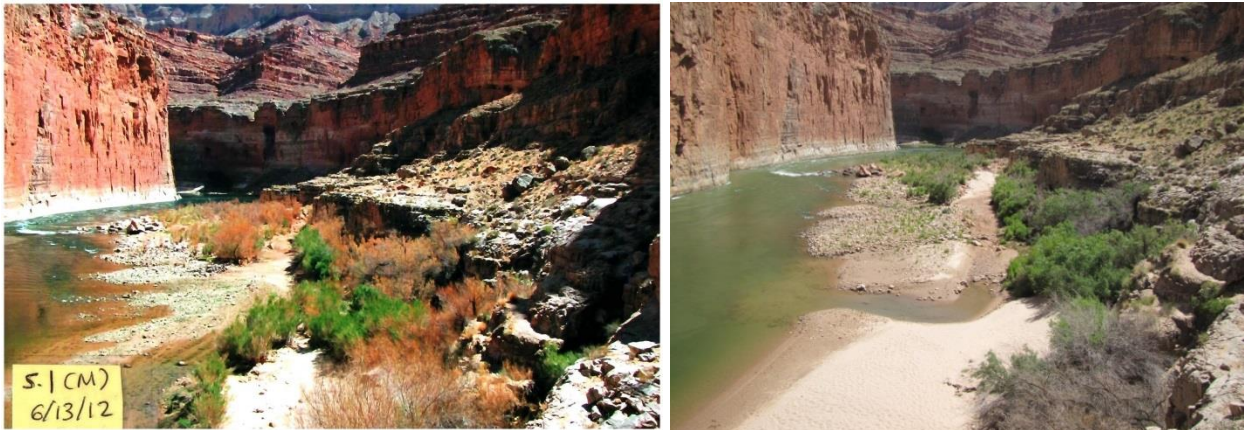
Figure 1.2 South Canyon: sediment change and continued build-up of the beach, photos looking downriver from 2012 (left) and 2015 (right)

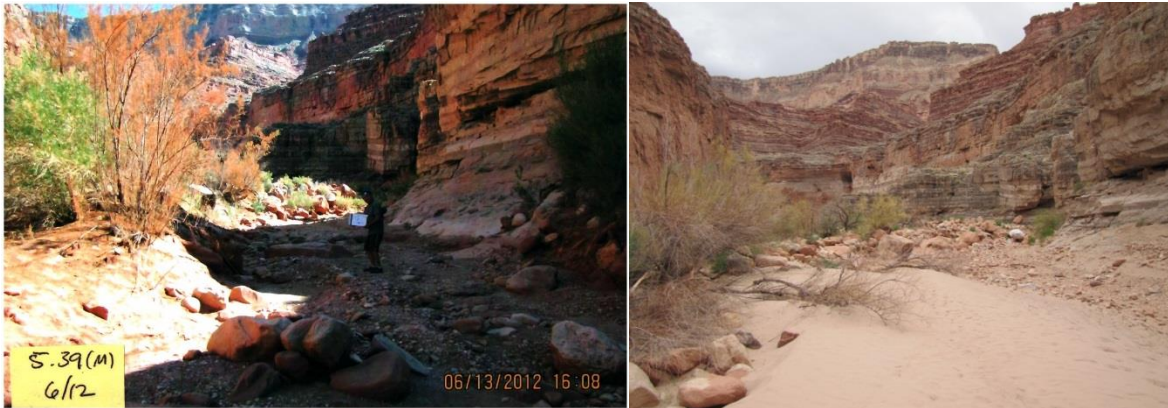
Figure 1.3. South Canyon: sediment change at the gully of the beach at South Canyon, showing sand bank deposits linked to HFES, photos from 2012 (left) and 2015 (right).

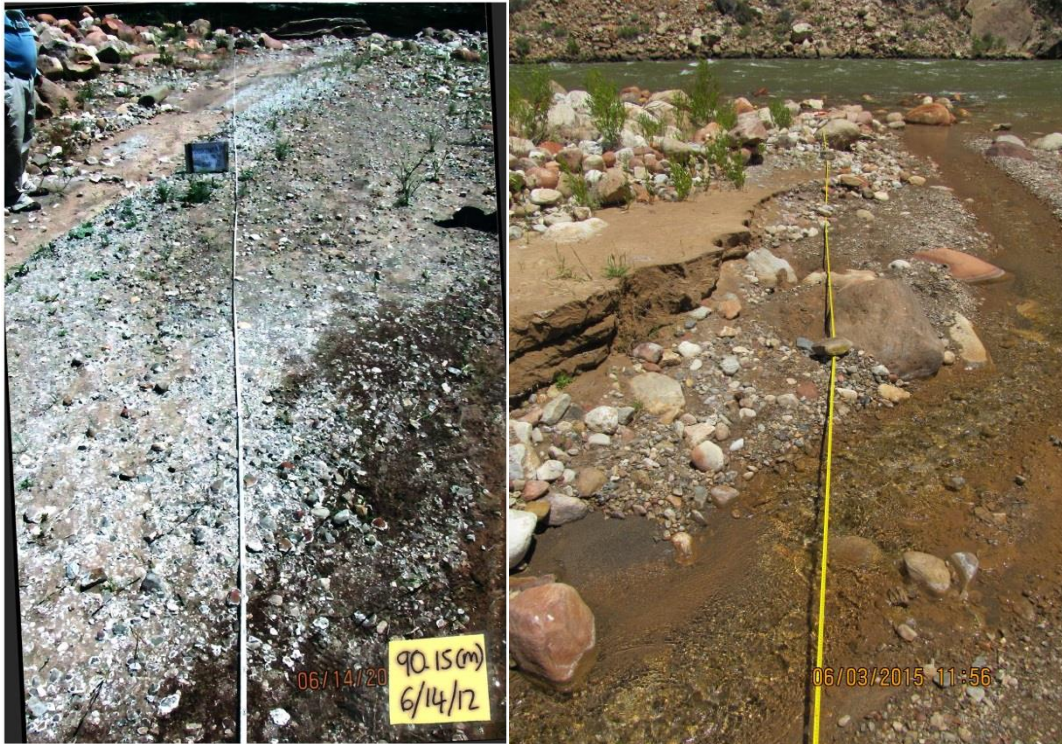
The vegetation at Nankoweap appeared to be thriving, and plant data will be collected in 2016. The plant transect lines were shorter when laid out. Figure 1.4 highlights the change in the water level of the Colorado River. Both images below show transect #4, taken at the same meter point, indicating some slight channeling in the Nankoweap creek bed and also a change in the Colorado River water level. In 2012 (photo on the left) the transect line measured 61 meters before reaching the Colorado River, while in 2015 (photo on the right) the transect line measured 51 meters before reaching the Colorado River. These changes will continue to be monitored.

Figure 1.4. Nankoweap: Image from transect #4, taken at the same meter point show some slight channeling in the creek bed. In 2012 (left) the transect line measured 61 meters before reaching the Colorado River, while in 2015 (right) the transect line measured 51 meters before reaching the Colorado River.

The SPC will bring a botanist on the 2016 monitoring trip in order to collect plant data. Additionally, the SPC will work next year to establish additional photo monitoring of the beach and vegetation in the creek bed. This effort responds to the ongoing use of high flow experiments and the Long-Term Experimental and Management Plan. The SPC will establish beach monitoring to collect additional data on the impacts of sediment and beach change brought about by the high flows.

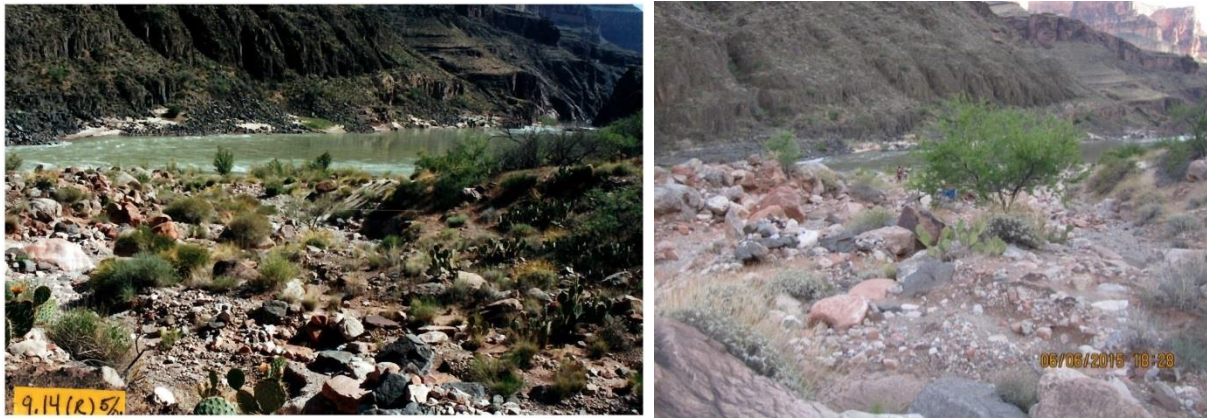
The plants at the Bedrock site appear similar to previous years, although slightly more verdant. Several new plants have grown.

Figure 1.5. Bedrock: Changes in vegetation and increased channeling in side canyon, photos from 2004 (left) and 2015 (right)

Due to the channeling in the wash, the SPC will re-establish monitoring photo points where needed when Bedrock is monitored again in 2019. Additionally, the SPC should consider adding additional monitoring photos overlooking the beach.

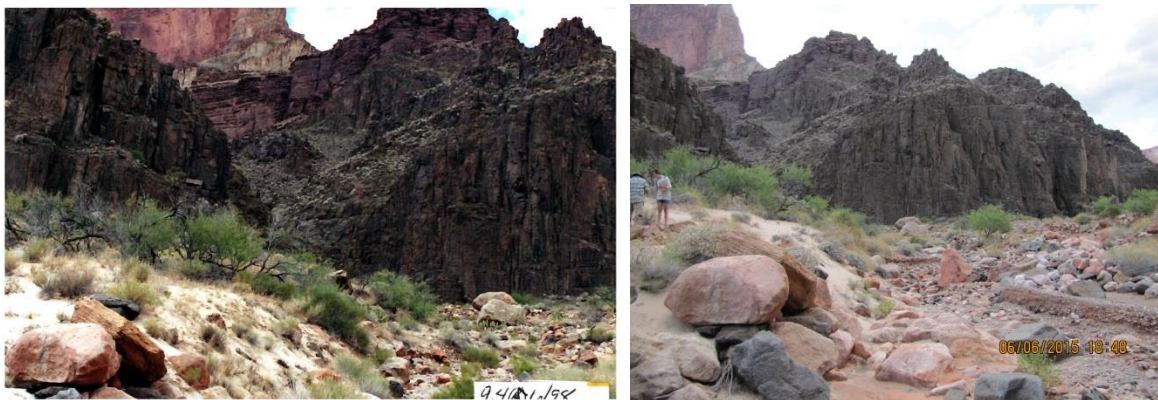
The archaeology at this site appeared without significant change, although mild erosion from natural impacts was noted. While the archaeology had not changed, the arroyo that abuts the roasting pits experienced channeling (see photos below). The channel cut alongside the roaster. At present the channel has not affected the roaster, but the SPC will continue to monitor changes in the channel. Additionally, the channeling affected two photo point locations that will need to be re-established.

Figure 1.6. Bedrock: Channeling in the arroyo at Bedrock site, photos from 1998 (left) and 2015 (right)

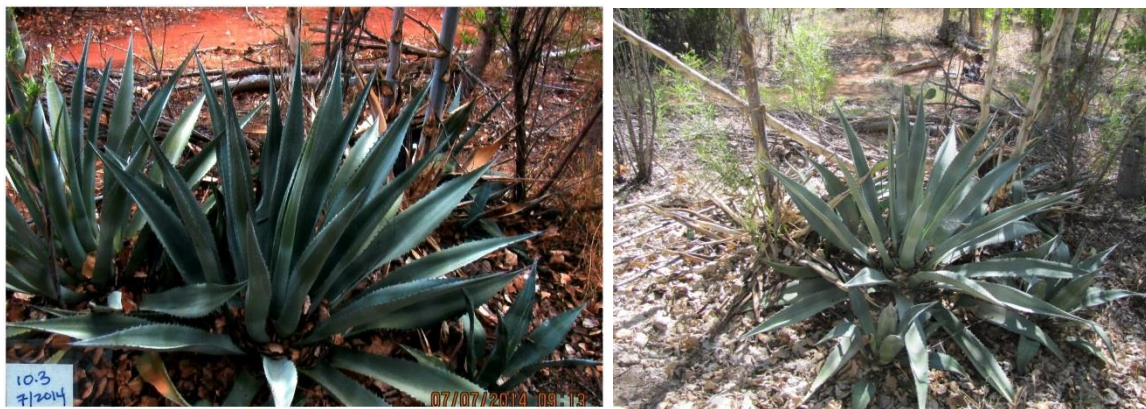
At the agave plot, some plants appear to be flourishing (i.e. locoweed), while others are struggling (i.e. the catclaw acacia, *senegalia greggii*, and the willows, *salix exigua*). The primary agave plot has four dead stalks and six live agave plants. The secondary agave plot still has a proliferation of pups or offsets and one older plant with a dead stalk. At the secondary plot, seven pups have grown to a diameter of 1 foot wide, but the rest are smaller. A faint trail was observed leading from the primary hiking trail to the secondary agave plot. It is unclear the impacts of this trailing on the plants.

Figure 1.7. Deer Creek Agave: Photos of the agave at plot 1 from 2014 (left) and 2015 (right).

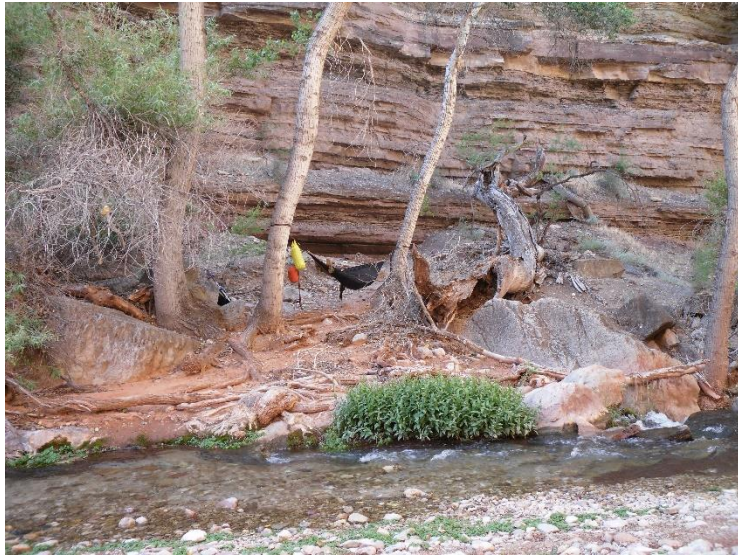
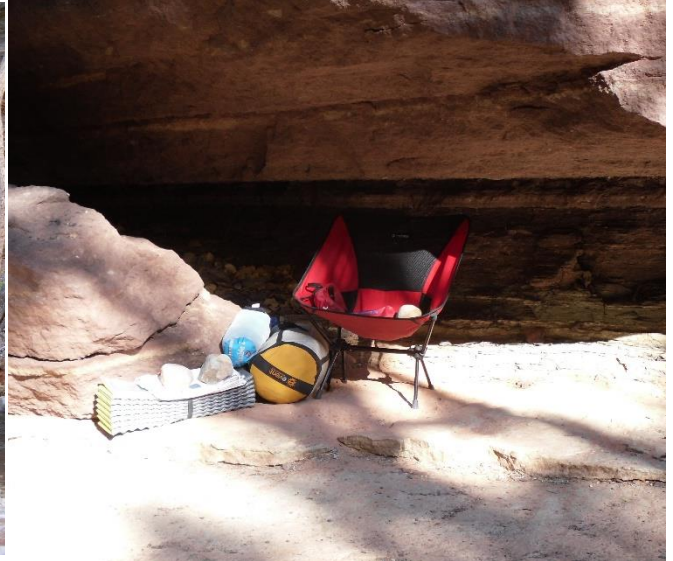
This year, several visitors engaged in problematic behavior in the upper portion of Deer Creek. When the SPC monitors reached the patio, they found a hiker camping in a hammock

strung between two cottonwood trees on the upriver side of the patio (see photo below). Additionally, in the afternoon when the patio was busy with visitors, one visitor was observed urinating in the upper patio waterfall. In total, 105 visitors were observed stopping at lower Deer Creek and at least 35 were observed at the patio.

NPS should address the issue of visitors urinating in Deer Creek and in the vicinity of the campground and agave plots. Information on bathroom procedures in side canyons and tributaries, including Deer Creek, should be included in materials handed out to hikers and river trip participants.

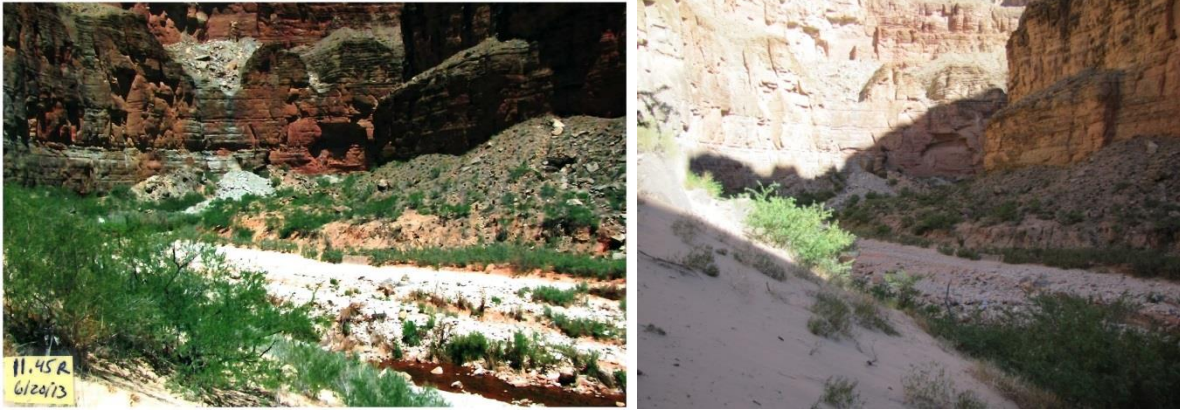
The SPC monitors noted continued changes at Kanab: sediment deposition and boulder shifting. Some tamarisk trees at the site have been washed away while others have taken root in cleared areas. In the upper portion of the Kanab beach, there were noted increases in sand deposition in comparison with previous years.

Figure 1.8. Kanab Creek: Sand deposits above Kanab Creek show an increase in deposition. Photos from 2013 (left) and 2015 (right).

Continued monitoring of the effects of regular HFEs and changes in the river channeling are recommended.

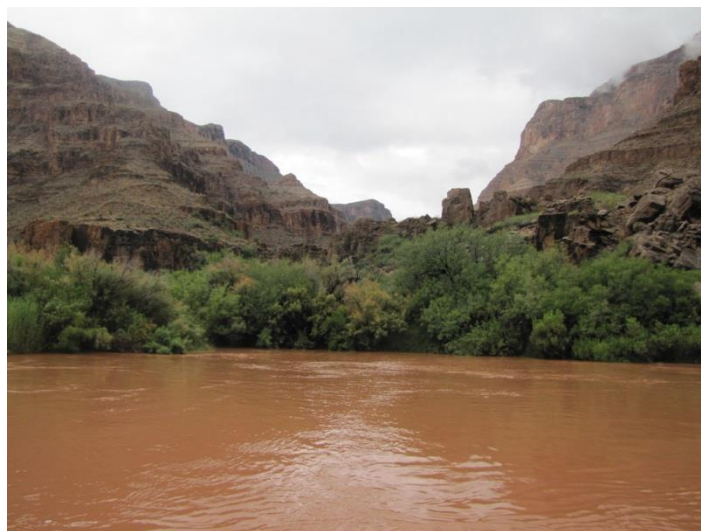
Spring Canyon was not monitored in 2015 because it had not flash-flooded. Given the overgrown vegetation, access to the site is extremely difficult. The thick vegetation, however, is also effectively protecting the site. Photos of Spring Canyon were taken from the river.

Figure 1.9. Spring Canyon: Photo from 2015 taken at the mouth of the canyon, which has not been scoured recently from a flash flood.

The SPC will monitor this site in 2016, contingent upon the flash-flooding of the canyon.

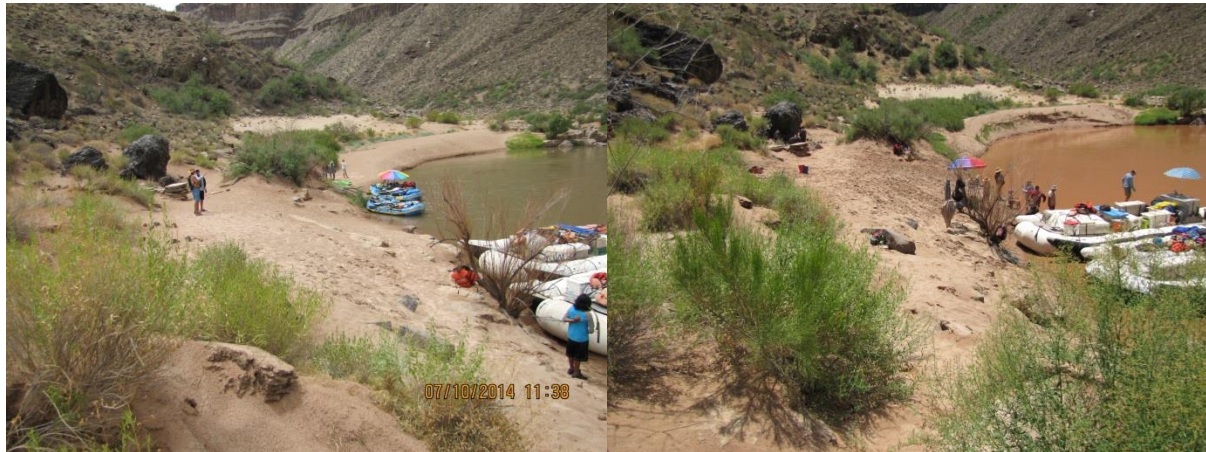
Spring and beach monitoring were conducted at this site in 2015. The water in the spring appeared murky, indicating it had not been flooded or scoured in some time, and algae was also present. SPC monitors noted that the downriver beach at Pumpkin Spring has been built up with sediment and currently has a steeper embankment than in previous years. The photos below show the change in the beach over the last two years.

Figure 1.10. Pumpkin Spring: Sand deposits on far side of beach downriver from Pumpkin Spring. Photos from 2014 (left) and 2015 (right).

The SPC will closely monitor the effects of regular HFEs on the spring and the adjoining beach.
