2015 SOUTHERN PAIUTE CONSORTIUM
Colorado River Corridor Resource Evaluation Program
Annual Report of Activities

Southern Paiute Consortium
Pipe Spring, Arizona
and
Bureau of Applied Research in Anthropology
University of Arizona
Tucson, Arizona

September 30, 2015

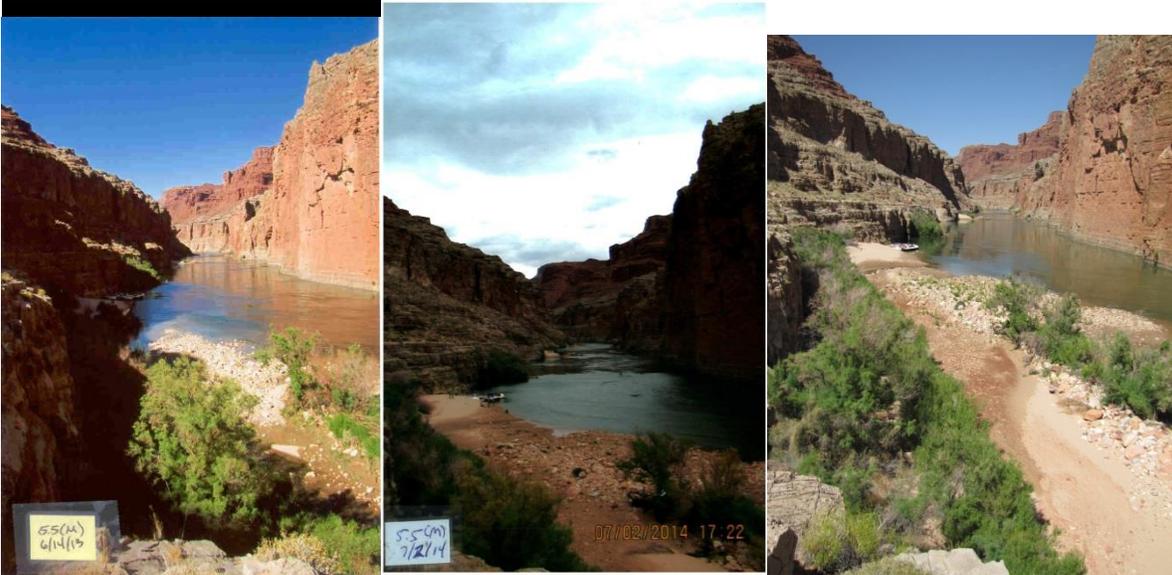
Beach monitoring was carried out in 2015. There are several notable changes. The November High Flood Experiment (HFE) has led to even greater deposition than the 2014 HFE. Midway up the canyon the wash was silted in with sand deposits likely from the HFEs. Additional effects of flooding at the site include boulder movement, greater debris and small rocks, and different height and placement of the sandbar. The deposition has covered many of the rock landmarks used during the photo matching.

Figure 1.1. South Canyon: sediment change and continued build-up of the beach, looking upriver 2013 (left), 2014 (middle), 2015 (right)

Visitation to this site remains high, so monitoring of this beach, the rock writing, hidden collection of artifacts at the rock structure, and trailing near the rock boulders will continue annually. The SPC has noted at this site that artifacts are being moved around, into collection piles, hidden, and likely sometimes removed. The SPC is concerned with this ongoing issue, and would like the NPS to address this through further monitoring and education. Furthermore, the SPC is concerned about the increase in trailing at this site, particularly from the middle bench to the rock structure. The SPC recommends that NPS address the increased trailing. Finally, continued monitoring of the effects of regular HFEs is recommended in order to track the effects of regular high flows and the associated management of the Glen Canyon Dam on the site.

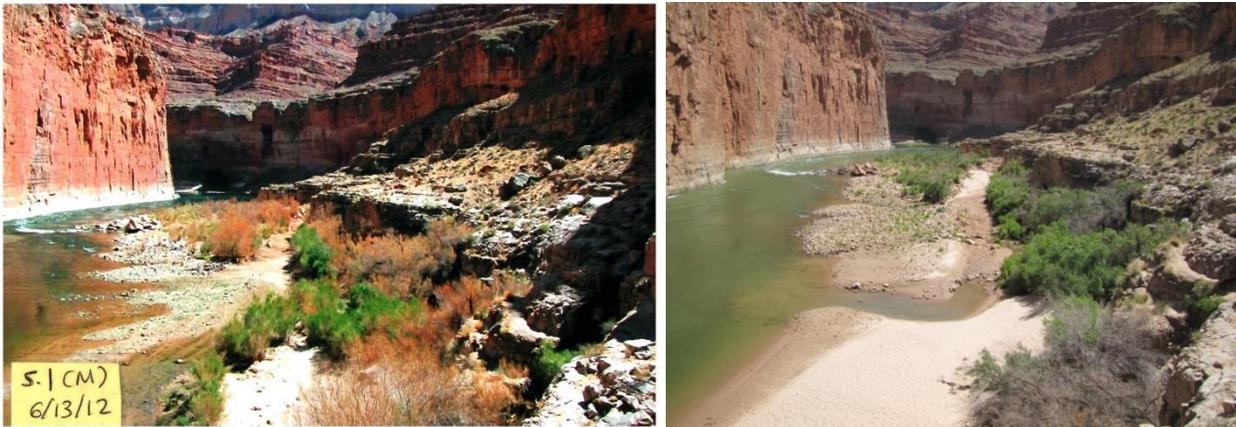
Figure 1.2 South Canyon: sediment change and continued build-up of the beach, photos looking downriver from 2012 (left) and 2015 (right)

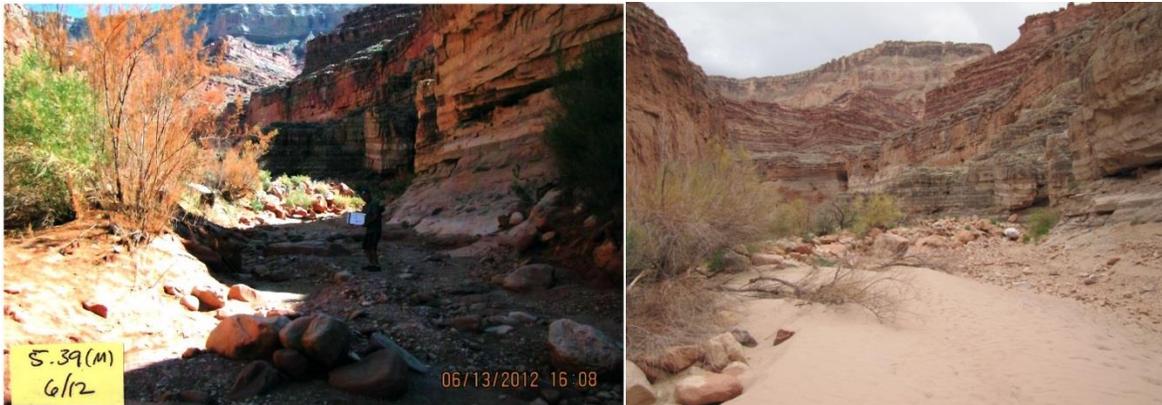
Figure 1.3. South Canyon: sediment change at the gully of the beach at South Canyon, showing sand bank deposits linked to HFES, photos from 2012 (left) and 2015 (right).

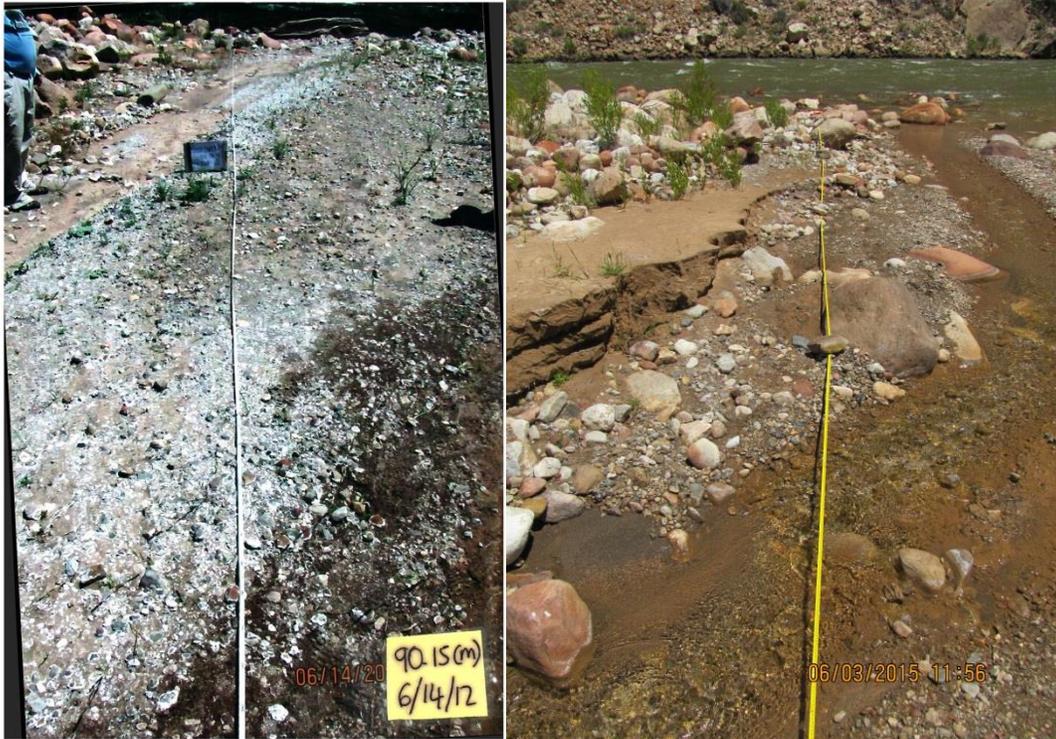
The vegetation at Nankoweap appeared to be thriving, and plant data will be collected in 2016. The plant transect lines were shorter when laid out. Figure 1.4 highlights the change in the water level of the Colorado River. Both images below show transect #4, taken at the same meter point, indicating some slight channeling in the Nankoweap creek bed and also a change in the Colorado River water level. In 2012 (photo on the left) the transect line measured 61 meters before reaching the Colorado River, while in 2015 (photo on the right) the transect line measured 51 meters before reaching the Colorado River. These changes will continue to be monitored.

Figure 1.4. Nankoweap: Image from transect #4, taken at the same meter point show some slight channeling in the creek bed. In 2012 (left) the transect line measured 61 meters before reaching the Colorado River, while in 2015 (right) the transect line measured 51 meters before reaching the Colorado River.

The SPC will bring a botanist on the 2016 monitoring trip in order to collect plant data. Additionally, the SPC will work next year to establish additional photo monitoring of the beach and vegetation in the creek bed. This effort responds to the ongoing use of high flow experiments and the Long-Term Experimental and Management Plan. The SPC will establish beach monitoring to collect additional data on the impacts of sediment and beach change brought about by the high flows.

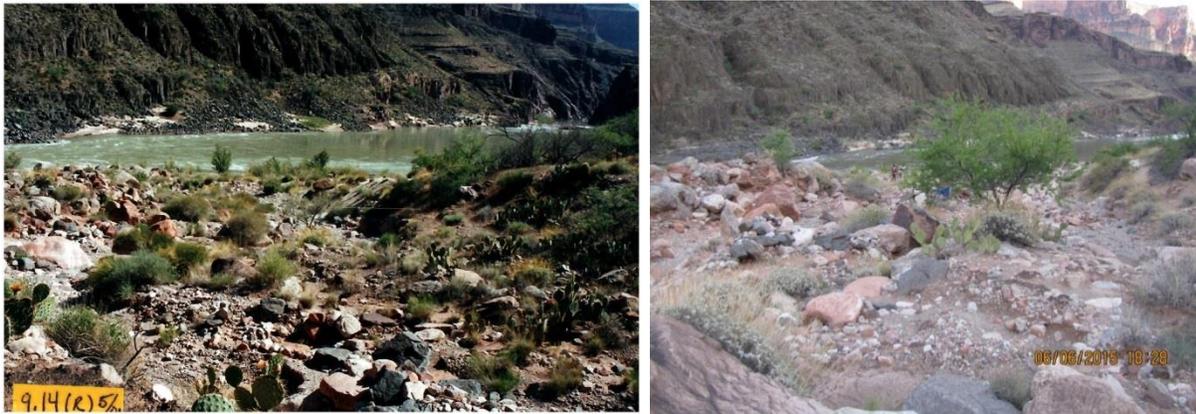
The plants at the Bedrock site appear similar to previous years, although slightly more verdant. Several new plants have grown.

Figure 1.5. Bedrock: Changes in vegetation and increased channeling in side canyon, photos from 2004 (left) and 2015 (right)

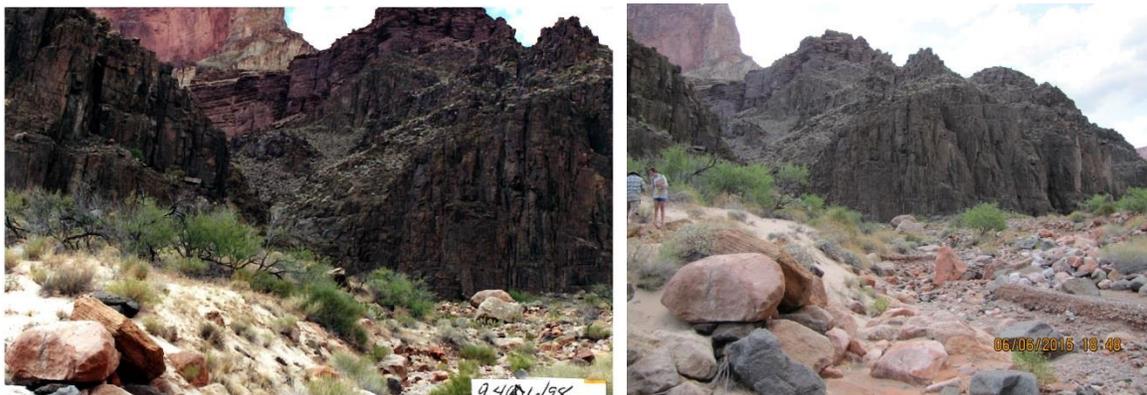
The archaeology at this site appeared without significant change, although mild erosion from natural impacts was noted. While the archaeology had not changed, the arroyo that abuts the roasting pits experienced channeling (see photos below). The channel cut alongside the roaster. At present the channel has not affected the roaster, but the SPC will continue to monitor changes in the channel. Additionally, the channeling affected two photo point locations that will need to be re-established.

Figure 1.6. Bedrock: Channeling in the arroyo at Bedrock site, photos from 1998 (left) and 2015 (right)

Due to the channeling in the wash, the SPC will re-establish monitoring photo points where needed when Bedrock is monitored again in 2019. Additionally, the SPC should consider adding additional monitoring photos overlooking the beach.

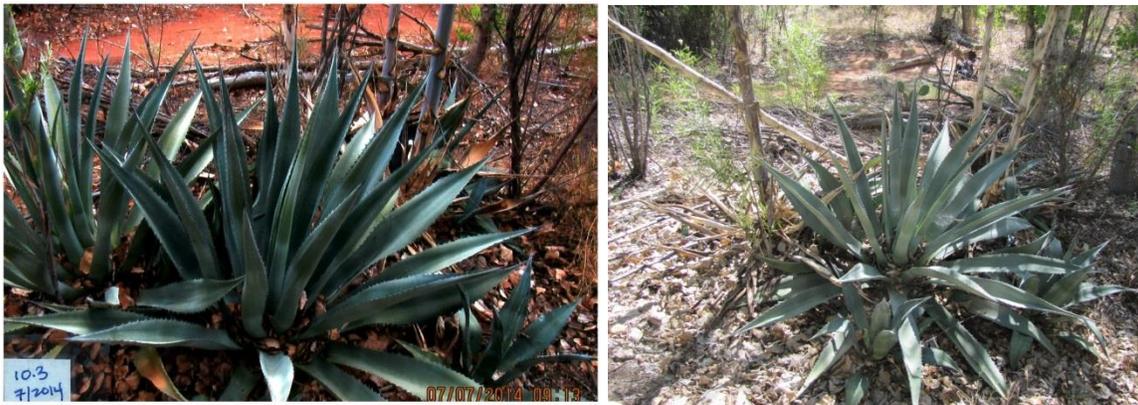
At the agave plot, some plants appear to be flourishing (i.e. locoweed), while others are struggling (i.e. the catclaw acacia, *senegalia greggii*, and the willows, *salix exigua*). The primary agave plot has four dead stalks and six live agave plants. The secondary agave plot still has a proliferation of pups or offsets and one older plant with a dead stalk. At the secondary plot, seven pups have grown to a diameter of 1 foot wide, but the rest are smaller. A faint trail was observed leading from the primary hiking trail to the secondary agave plot. It is unclear the impacts of this trailing on the plants.

Figure 1.7. Deer Creek Agave: Photos of the agave at plot 1 from 2014 (left) and 2015 (right).

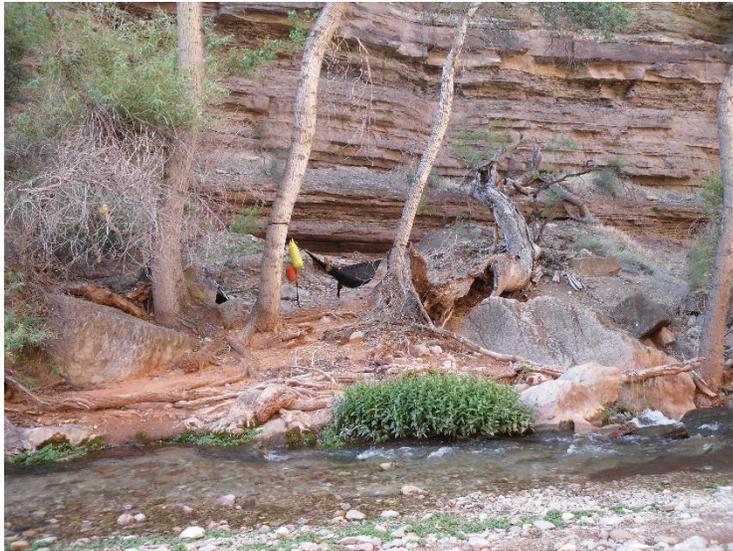
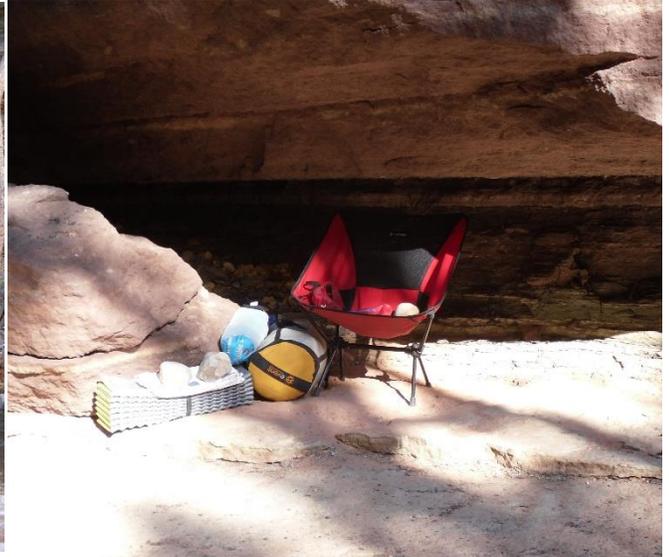
strung between two cottonwood trees on the upriver side of the patio (see photo below). Additionally, in the afternoon when the patio was busy with visitors, one visitor was observed urinating in the upper patio waterfall. In total, 105 visitors were observed stopping at lower Deer Creek and at least 35 were observed at the patio.

NPS should address the issue of visitors urinating in Deer Creek and in the vicinity of the campground and agave plots. Information on bathroom procedures in side canyons and tributaries, including Deer Creek, should be included in materials handed out to hikers and river trip participants.

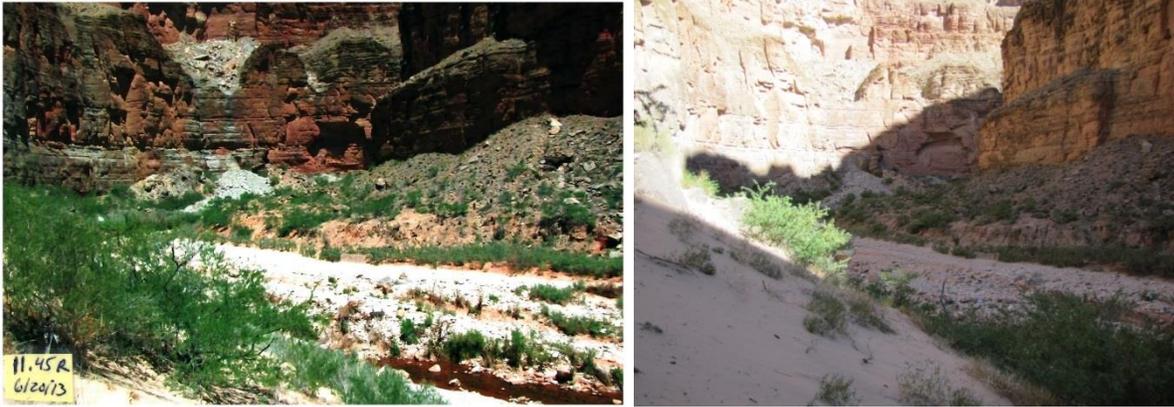
The SPC monitors noted continued changes at Kanab: sediment deposition and boulder shifting. Some tamarisk trees at the site have been washed away while others have taken root in cleared areas. In the upper portion of the Kanab beach, there were noted increases in sand deposition in comparison with previous years.

Figure 1.8. Kanab Creek: Sand deposits above Kanab Creek show an increase in deposition. Photos from 2013 (left) and 2015 (right).

Continued monitoring of the effects of regular HFEs and changes in the river channeling are recommended.

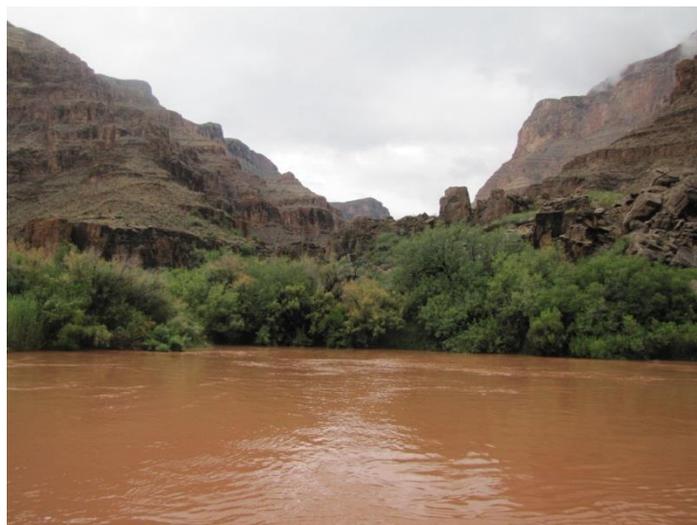
Spring Canyon was not monitored in 2015 because it had not flash-flooded. Given the overgrown vegetation, access to the site is extremely difficult. The thick vegetation, however, is also effectively protecting the site. Photos of Spring Canyon were taken from the river.

Figure 1.9. Spring Canyon: Photo from 2015 taken at the mouth of the canyon, which has not been scoured recently from a flash flood.

The SPC will monitor this site in 2016, contingent upon the flash-flooding of the canyon.

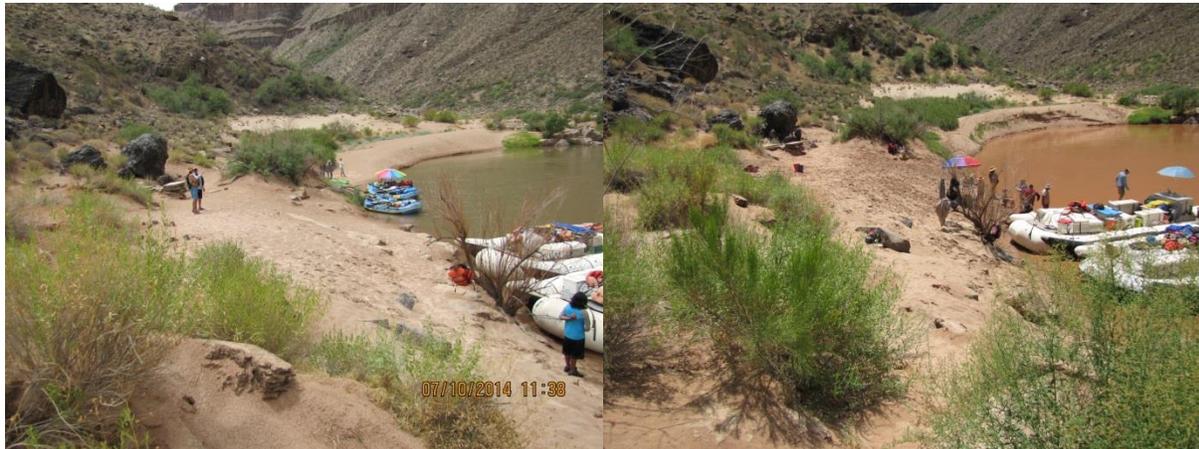
Spring and beach monitoring were conducted at this site in 2015. The water in the spring appeared murky, indicating it had not been flooded or scoured in some time, and algae was also present. SPC monitors noted that the downriver beach at Pumpkin Spring has been built up with sediment and currently has a steeper embankment than in previous years. The photos below show the change in the beach over the last two years.

Figure 1.10. Pumpkin Spring: Sand deposits on far side of beach downriver from Pumpkin Spring. Photos from 2014 (left) and 2015 (right).

The SPC will closely monitor the effects of regular HFEs on the spring and the adjoining beach.
