Technical Memorandum No. MERL-2014-64

Coatings for Mussel Control — Results from Six Years of Field Testing

U.S. Department of the Interior Bureau of Reclamation Technical Service Center Denver, Colorado

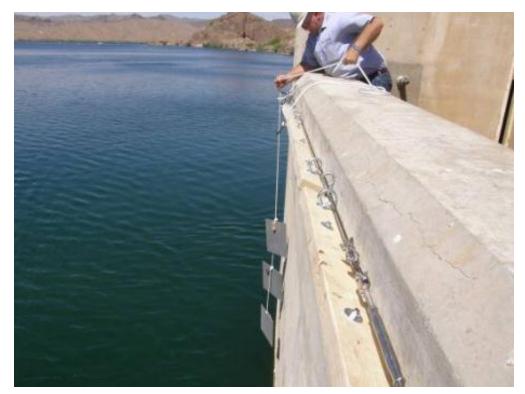
Figure 2. Coated steel plates placed in static exposure from the face of Parker Dam.

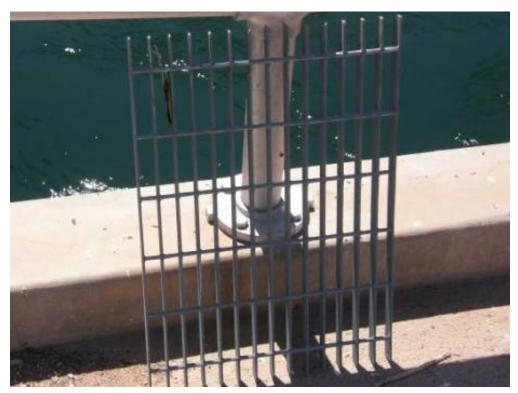
Figure 3. Coated floor grate before being hung from the forebay trashrack structure at Parker Dam.

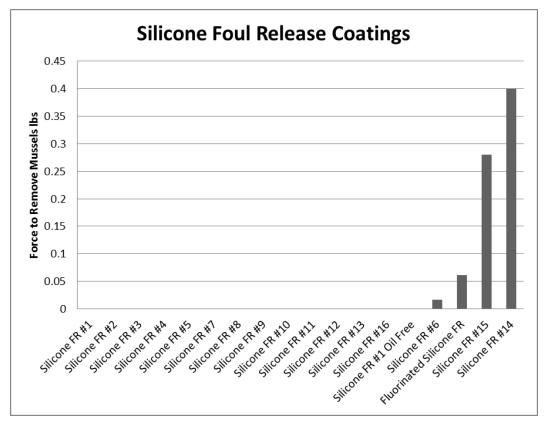
Figure 5. Force measurements for silicone and fluorinated silicone foul-release coatings.

Silicones FR #14 and #15 were withdrawn from the study due to mussel attachment and were not able to self-clean. The mussels caused 100-percent blockage of the coated floor grates in flowing conditions. Silicones FR #14 and #15 were designed as erosion-resistant silicone coatings (higher modulus), but the manufacturer stated that the products would resist quagga mussel attachment. The products were easily cleaned, requiring 0.25 to 0.4 pounds of force to remove mussels, but were not self-cleaning.

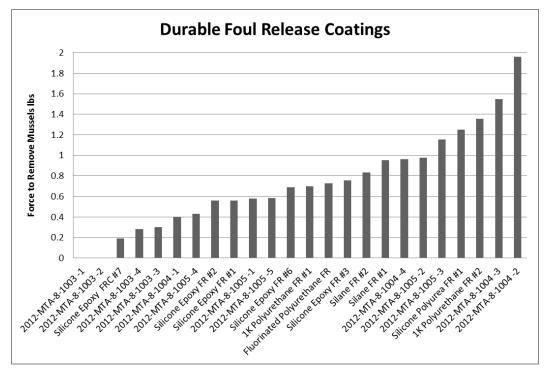
Most durable foul-release coatings that MERL tested allow mussels to attach to the coating surface with varying amounts of force, as shown in Figure 7. The mussels build up significantly and can cause 100-percent blockage and severe flow restriction through the coated grates. Although the mussels attach with varying force, they remain attached to the surface without being released under the test conditions; i.e., the tested coatings generally are not self-cleaning. The only exceptions among the systems currently being evaluated are Silicone Epoxy #7 and 2012-MTA-8-1003 #1 and #2. It is premature to make any conclusions regarding the effectiveness of these systems. Silicone Epoxy #7 allowed mussel attachment requiring 0.2 lbs of force to remove a mussel, but appears to be selfcleaning for the first 12 months of exposure, as shown in Figure 8. The two experimental formulations from the Material Transfer Agreement (MTA) prevented mussel attachment, for the first 18 months of exposure, as shown in Figure 9. In that image, mussels are attached to the backs of the panels and to zipties between the panels. In places, chains or "curtains" of mussels anchored on the backs of the panels wrap around to the front side. Up to this point, selfcleaning and prevention of attachment was only observed for silicone and fluorinated silicone foul-release systems. All other durable foul-release coatings evaluated allowed mussel attachment, as described in Table 2. The coatings listed in Table 2 would be easier to clean than a traditional epoxy coating, according to the force measurements. The self-cleaning property was not observed with the durable foul-release coatings listed in Table 2.

Figure 7. Force measurements for durable foul-release coatings.

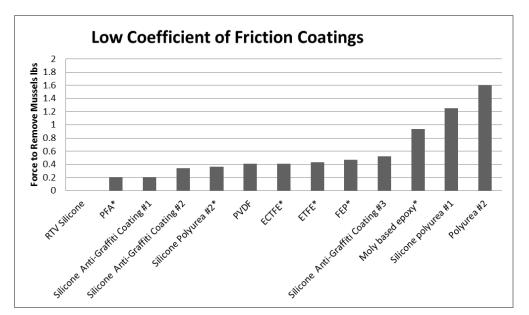
Low coefficient-of-friction coatings were not designed to prevent mussel attachment; however, MERL has found that some of them have lower release force than the most of the durable foul-release coatings. Figure 11 shows the release force for mussels of various low coefficient-of-friction coatings. Even though these coatings have low release forces, the coatings allow the mussels to attach and are not self-cleaning under the testing conditions at Parker Dam. It is unknown if these coatings would self-clean under higher flow rates.

Figure 11. Force measurements for low coefficient-of-friction coatings.
